**RCRA Compliance Branch
INSPECTION REPORT**

Inspection Date(s):	07/23/2019 – 07/25/2019		Inspection Announced: No
Facility or Site Name:	Troy Chemical Corporation		
Facility/Site Physical Location:	One Avenue L		
(city, state, zip code)	Newark, NJ 07105		
Mailing address (if different from above):	One Avenue L		
(city, state, zip code)	Newark, NJ 07105		
Facility/Site Contact:	Bill Reilley	Environmental Manager	
	reilleyw@troycorp.com		
	973-508-4628		
RCRA ID Number:	NJD002144517 *		
Facility/Site Personnel Participating in Inspection:			
Alexander Gerardo	Vice President of Government Affairs	gerardoa@troycorp.com / 973-477-0559	
Sam Eskander	General Manager	eskanders@troycorp.com / 973-589-0490	
Donn Hirschmann	Environmental Health and Safety Group Director	hirschmannd@troycorp.com / 973-589-2500	
Jim Manzella	Process Safety Manager	manzellaj@troycorp.com / 973-589-2500	
Bill Reilley	Environmental Manager	reilleyw@troycorp.com / 973-508-4628	
Rob Zedeck	Plant Manager	zedeckr@troycorp.com / 973-589-2500

At the request of EPA Region 2, EPA Headquarters supported by Eastern Research Group, Inc. (ERG) conducted a Resource Conservation and Recovery Act (RCRA) compliance evaluation

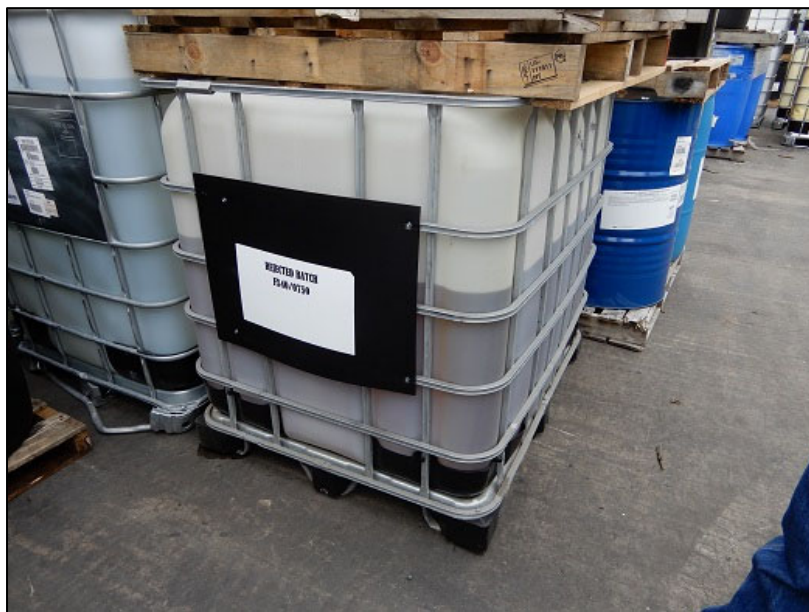
1. {View of a tote labeled "Rejected Batch FX40/0759." The EPA Inspection Team requested follow-up information from the facility as to the hazards associated with this batch.}

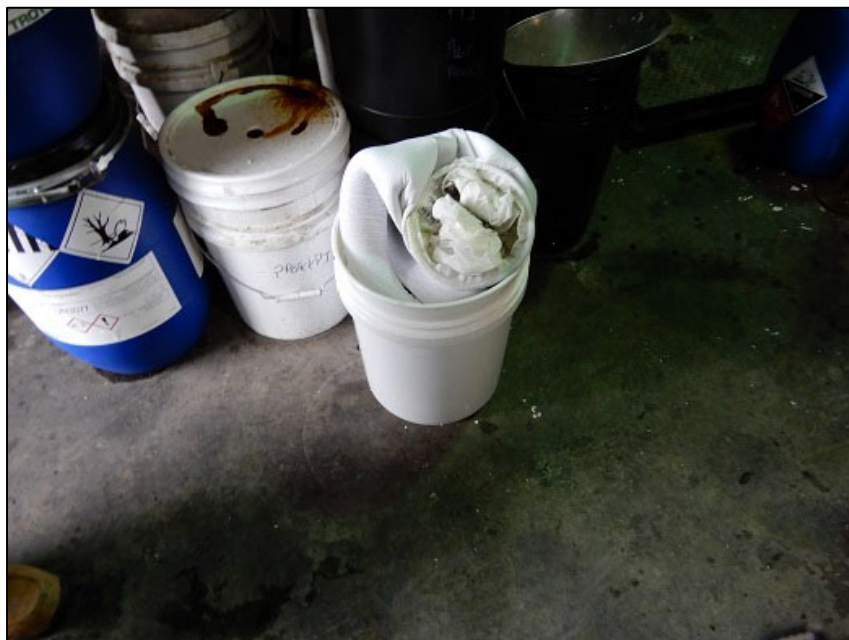
{Photograph 2}

The inspection team conducted a walkthrough of Building 40. Building 40 contains the Pilot Plant and two batch reactors. The inspection team observed a filter in an open, unlabeled 5-gallon bucket in the Pilot Plant area. Mr. Zedeck stated the filter was from the pilot plant. It was unclear if this was considered a hazardous waste. The inspection team requested a waste profile for the filter waste stream.

2. {View of a spent filter in a bucket located in Building 40. The EPA Inspection Team requested a hazardous waste profile for this material.}

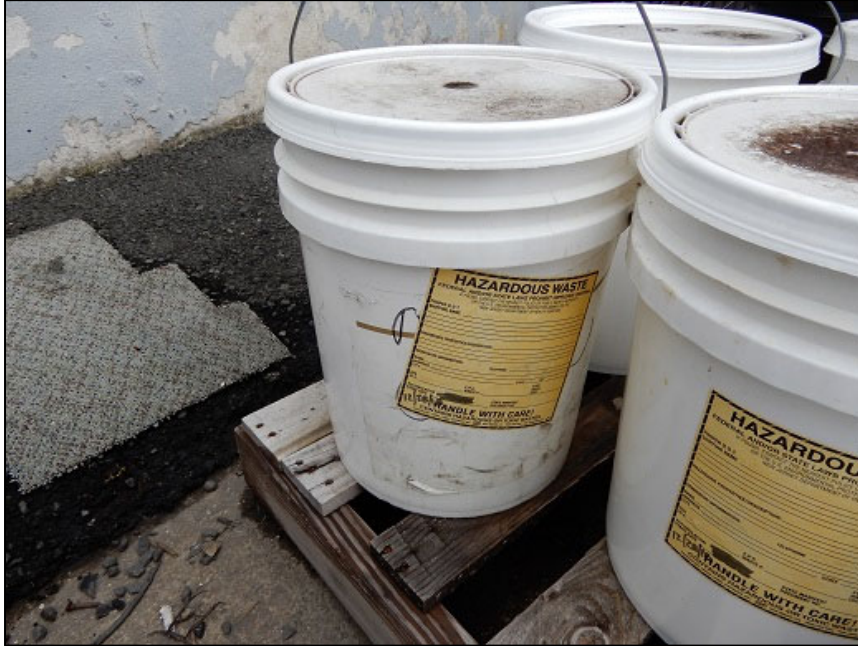
{Photograph 4}

- a) One pallet of 5-gallon buckets with the following areas of concern identified:
 1. Two 5-gallon buckets of hazardous waste dated 12/28/2018. The writing on the labels was faded and unreadable. The contents and the hazards of the material in the containers were not identified on the label.
 2. Seven of the 5-gallon buckets were unlabeled.
 3. Three 5-gallon buckets labeled "PF waste."
 4. Two 5-gallon buckets were labeled "WH1501CT Oleic Acid"
 5. One 5-gallon bucket was labeled "Tris Amino Waste"
- b) One wet and dented fiber drum labeled "Aminoacetic Acid."
- c) Four 55-gallon drums, one tote, and one overpack drum labeled Mergal 758 that were not dated.
- d) One unlabeled 5-gallon container.
- e) Three 55-gallon drums dated 12/19/2018 were labeled "On Hold Pending Analysis"
- f) Two 55-gallon drums only dated 12/2018.

3. {View of hazardous waste buckets in the 90-day storage area dated "12/28/18." Based on the date, the buckets had been in the 90-day storage area for 207 days.}

- Two 5-gallon buckets of hazardous waste dated 12/28/2018 in the 90-day storage area.
- Three 55-gallon drums dated 12/19/2018 in the 90-day storage area labeled "On Hold Pending Analysis"

Troy disposed of hazardous wastes and nonhazardous wastes from the 90-day storage area after the inspection (See Photograph 1 Attachment 14). Troy relabeled the roll-off containers and cleared the area around the roll-offs for better access (See Photograph 7 Attachment 14).

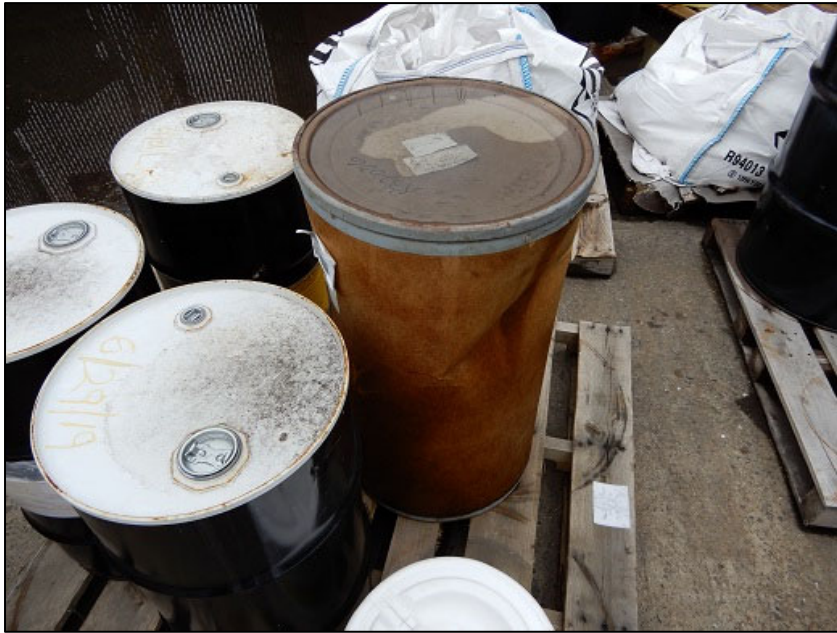
{Photograph 5}

4. {View of a fiber drum in the 90-day storage area with a large dent. The drum was labeled “Aminoacetic Acid.”}

- One wet and dented fiber drum in the 90-day storage area labeled "Aminoacetic Acid."
 - A 55-gallon drum located south of Building 71 containing hazardous materials completely corroded through with sections of the drum missing.
 - A corroded 55-gallon drum located south of Building 71 with an open bung hole in the lid. The drum was labeled "Atlas G-5000."
 - A corroded 55-gallon drum I located south of Building 71 labeled "Sodium Hydroxide, Solid" resting on top of a pallet placed on other drums.
3. 40 CFR 262.17(a) states, "*Accumulation*. A large quantity generator accumulates hazardous waste on site for no more than 90 days, unless in compliance with the accumulation time limit extension or F006 accumulation conditions for exemption in paragraphs (b) through (e) of this section."

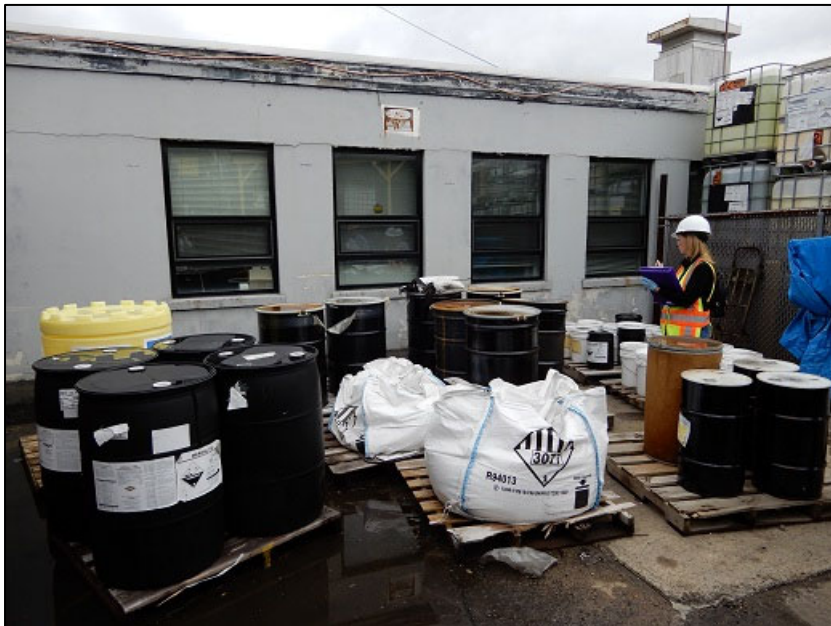
{Photograph 6}

5. {View of the 90-day storage area. The hazardous waste buckets and fiber drum from Photograph 5 and Photograph 6 are shown.}

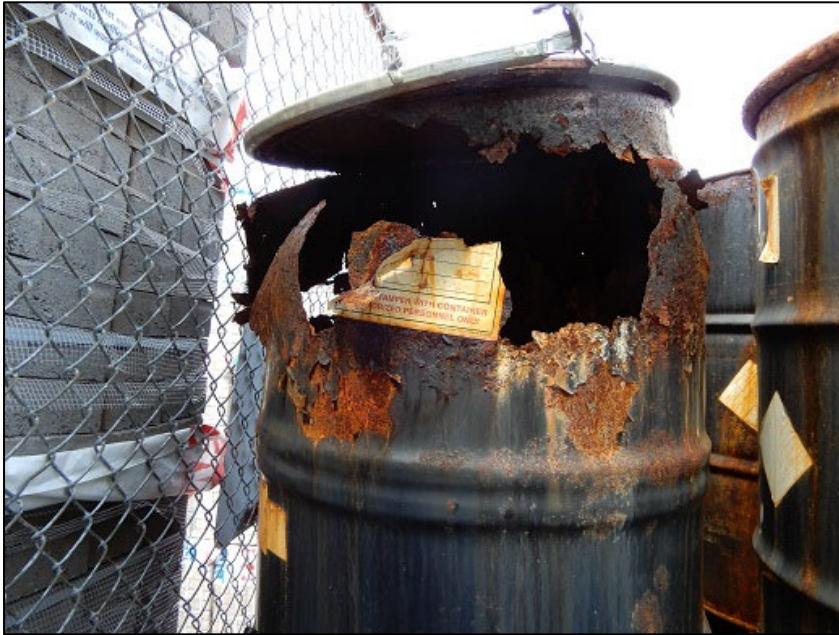
{Photograph 7}

- a) A 55-gallon drum with significant corrosion with a large portion of the drum open. The drum was half-full of brown-yellow liquid. The drum was labeled "Caustic Soda."
- b) A corroded 55-gallon drum with an open bung hole in the lid. The drum was labeled "Atlas G-5000."
- c) A corroded 55-gallon drum labeled "Sodium Hydroxide, Solid" resting on top of a pallet placed on other drums.

6. {View of a 55-gallon drum with significant corrosion on the south side of Building 71. A large portion of the drum was open, and the drum was half-full of brown-yellow liquid. The drum was labeled "Caustic Soda."}

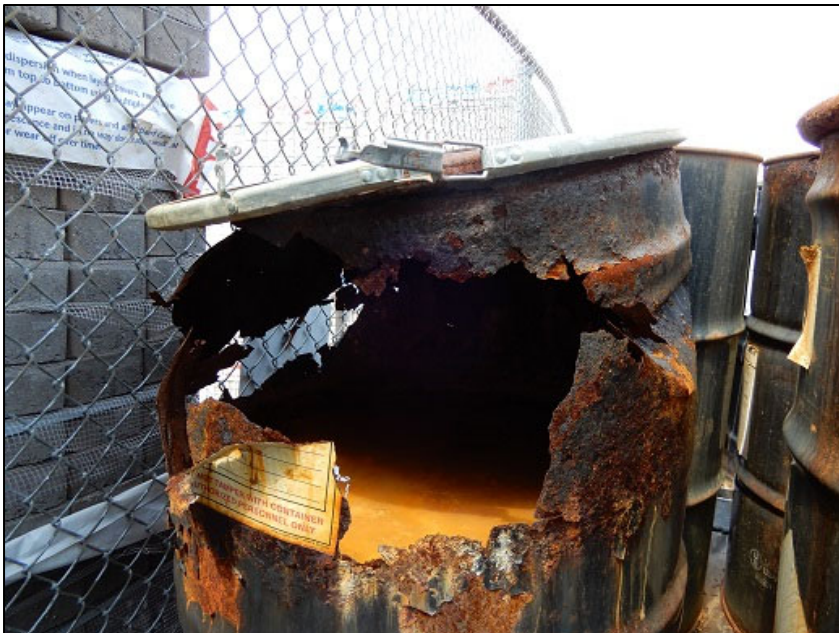
{Photograph 8}

7. {Alternate view of a 55-gallon drum with significant corrosion on the south side of Building 71. A large portion of the drum was open, and the drum was half-full of brown-yellow liquid. The drum was labeled "Caustic Soda."}

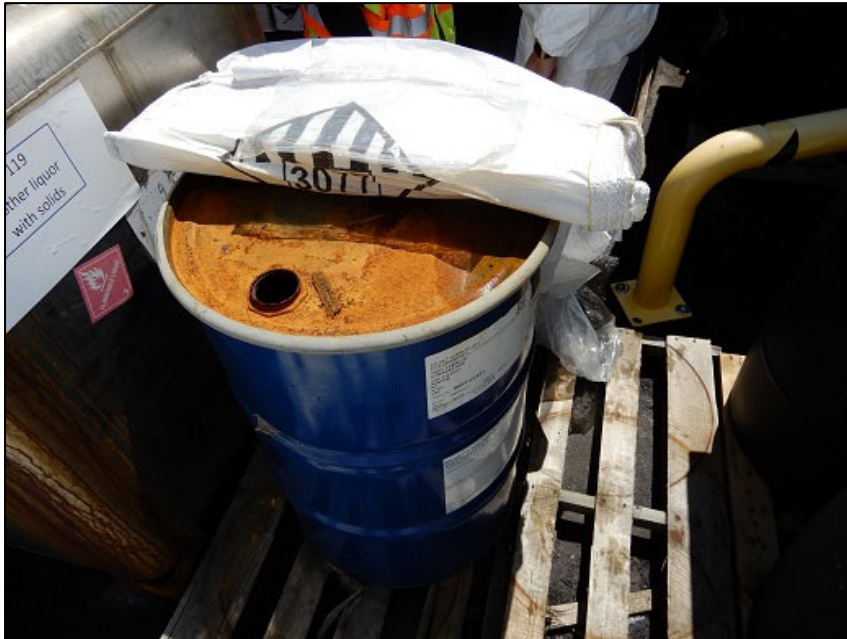
{Photograph 10}

8. {View of a corroded 55-gallon drum with an open bung hole in the lid on the south side of Building 71. The drum was labeled “Atlas G-5000.”}

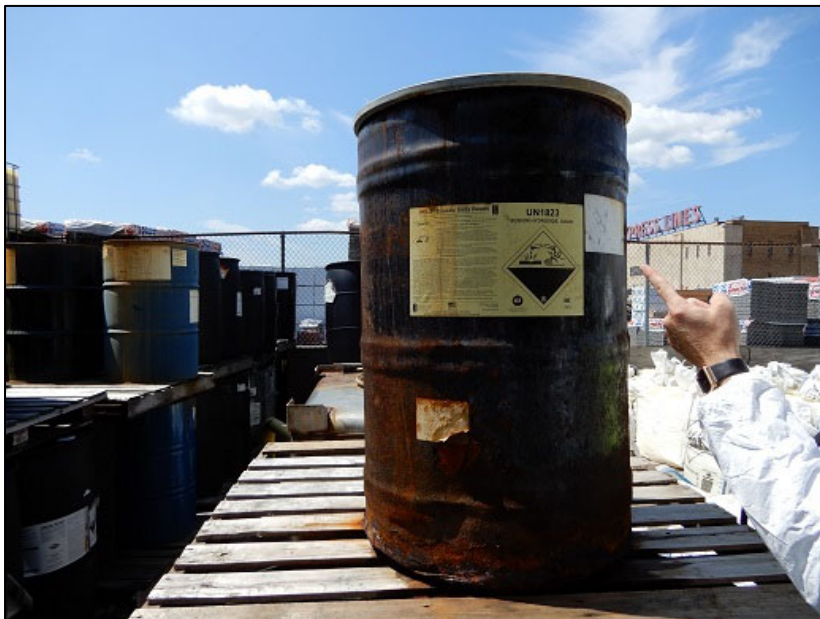
{Photograph 13}

9. {View of a corroded 55-gallon drum on the south side of Building 71. The drum was labeled “Sodium Hydroxide, Solid” and was on top of a pallet placed on other drums.}

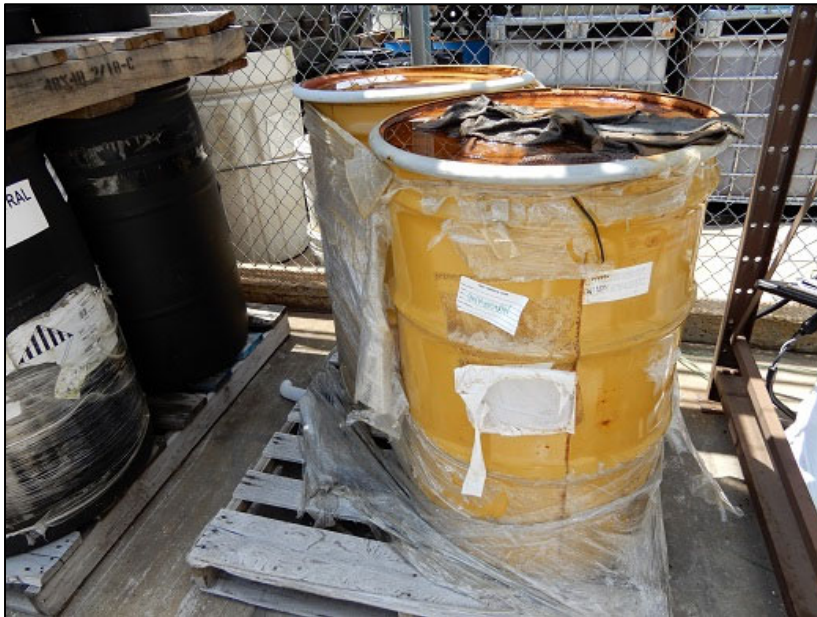
{Photograph 15}

- a) Two 55-gallon yellow drums with a label that identified the drums as containing “Fungitrol 404DS Fungicide;” however, another label on the drum indicated that its contents were unknown.
- b) At least six 55-gallon drums containing flammable liquids with heavy corrosion and bulging on top of the drums.
- c) Four 55-gallon drums with duct-tape covering the lids. The label identified the contents of the drums as “Zinc Pyrithione.”
- d) Two fiber drums with significant staining observed on the outside of the drums.

10. {View of two 55-gallon drums inside the QA Cage labeled “Unknown.”}

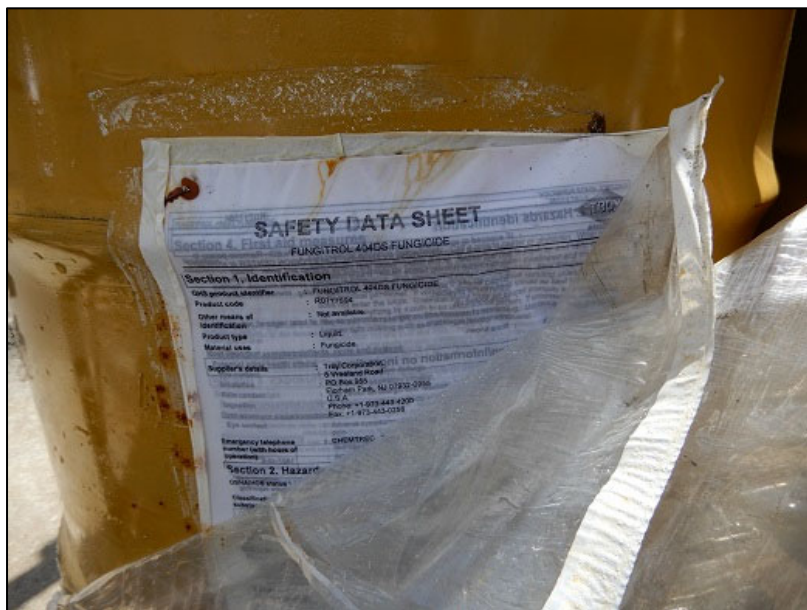
{Photograph 16}

11. {View of the label for one of the yellow 55-gallon drums from Photograph 16. This label identifies the drum as containing “Fungitrol 404DS Fungicide;” however, another label on the drum indicated that its contents were unknown.}

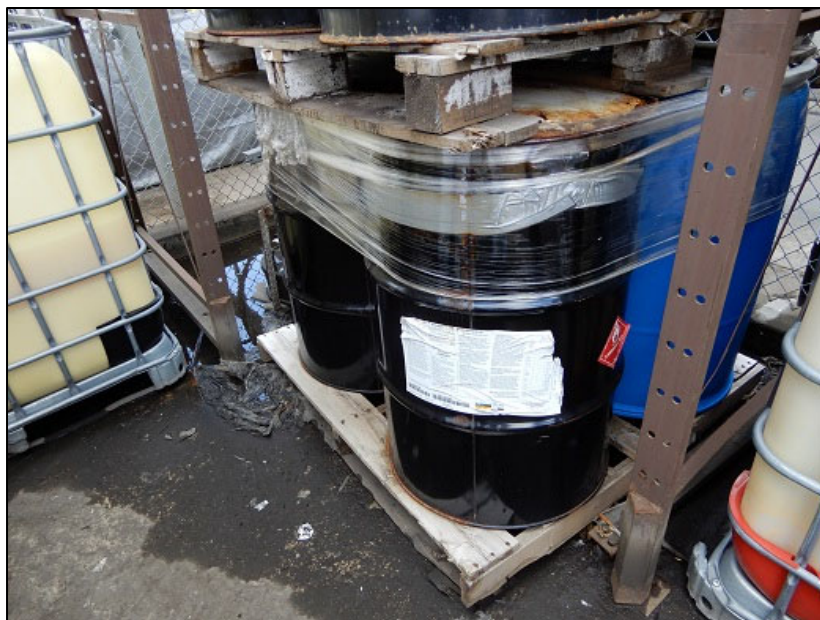
{Photograph 17}

12. {View of a flammable liquid with heavy corrosion and bulging on top of the drum inside the QA Cage. Note that there was a pallet with additional 55-gallon drums stored on top of this drum.}

The inventory of the QA Cage did not have dates the material entered the QA Cage. As a result, the inspection team could not make any determinations concerning speculative accumulation. Based on the observations of corrosion of numerous drums in the QA Cage, the inspection team believes that many of the drums in the QA Cage are corroded and in poor condition with bulging lids, therefore, have been in the QA Cage for more than a year.

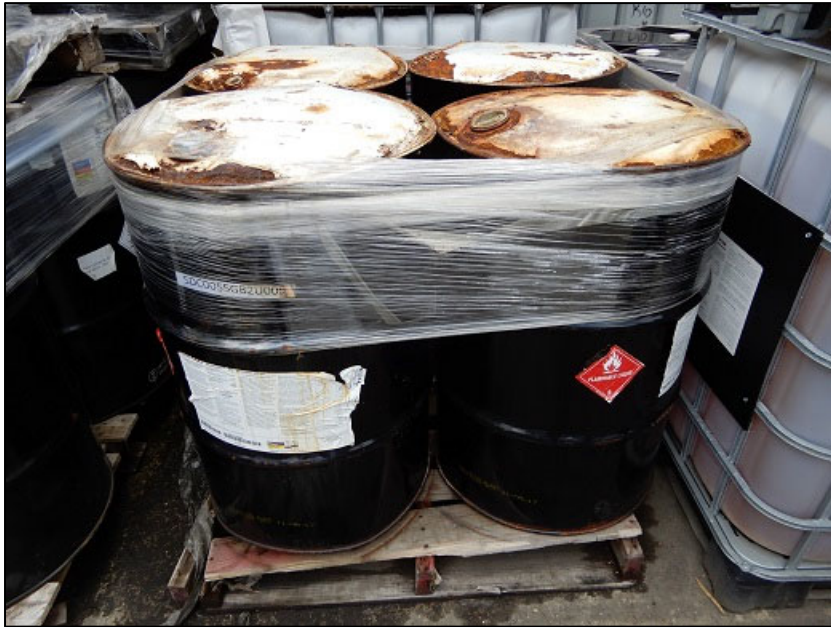
{Photograph 18}

13. {View of four 55-gallon drums inside the QA Cage containing flammable liquids with heavy corrosion and bulging on top of the drums.}

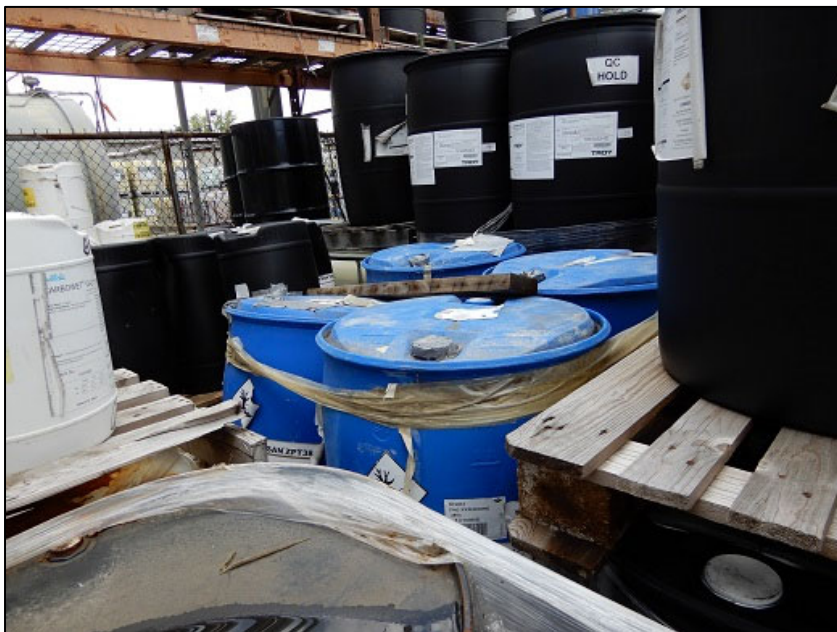
{Photograph 19}

14. {View of four 55-gallon drums inside the QA Cage with duct-tape covering the lids. The label identified the contents of the drums as “Zinc Pyrithione.”}

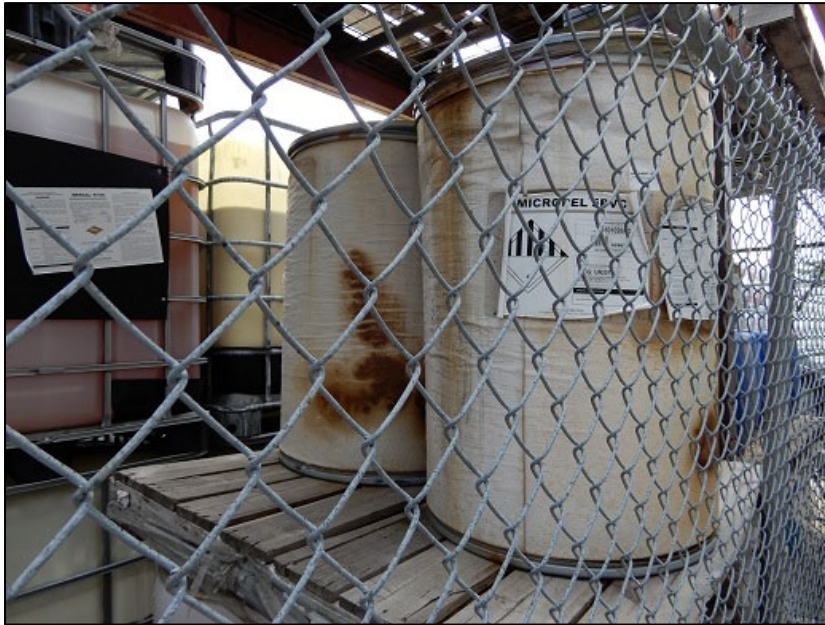
{Photograph 20}

15. {View of two fiber drums stored outside in the QA Cage. Significant staining was observed on the outside of the drums.}

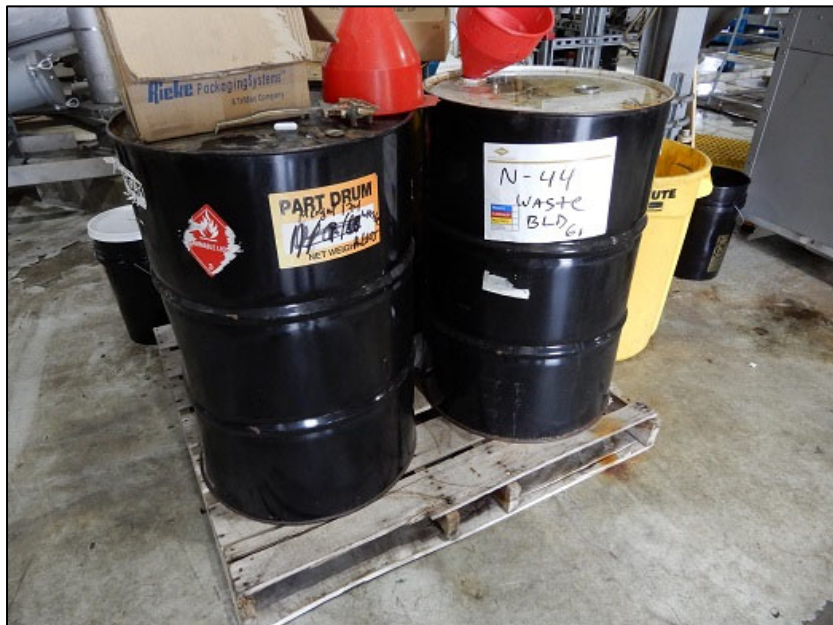
{Photograph 21}

- a) Two 55-gallon drums without proper hazardous waste labeling. One drum had a flammable liquid diamond, labeled “waste”, and also labeled with a product name “Mergal 174”. The second drum was labeled “N-44” and “waste.” The second drum was open and had a funnel inside of the lid. According to Mr. Zedeck, both drums contained nonhazardous waste and would be labeled as such.
- b) An unlabeled, open 5-gallon container next to the two drums above contained an unknown liquid. A nearby 5-gallon bucket was labeled “Dirty PF.”
- c) Two open, unlabeled 5-gallon buckets containing an unknown liquid. Mr. Zedeck believed the material was Mergal 174 but that would need to be confirmed.
- d) Two open, unlabeled 5-gallon buckets containing an unknown liquid inside Building 61. Mr. Zedeck believes the material was collected from R-6105.

16. {View of two 55-gallon drums with unclear labels in Building 61. The drum on the left is labeled as a flammable liquid. It is both labeled with a product name (i.e., Mergal 174) and “waste”. The drum on the right is also labeled “N-44” and “waste.” The drum on the right was open and had a funnel inside of the lid.}

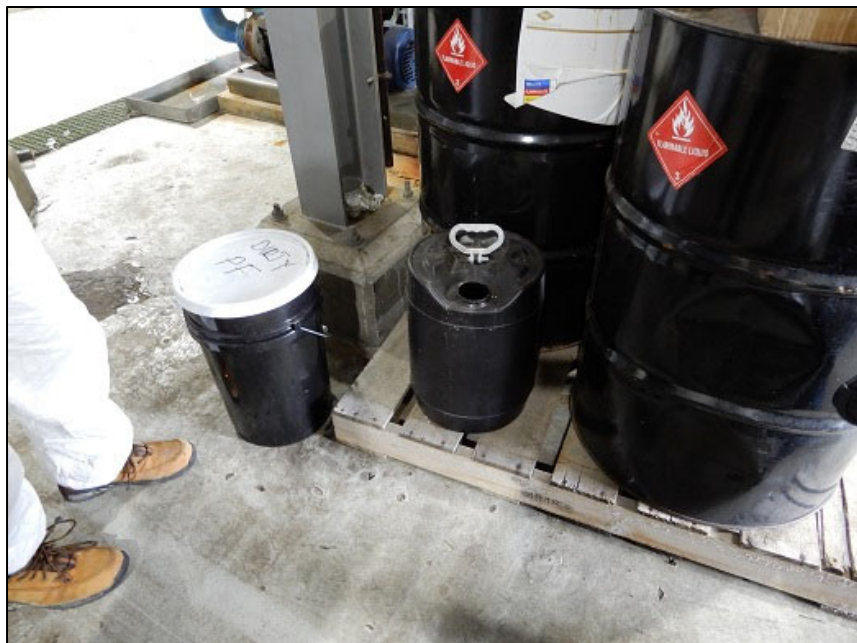
{Photograph 23}

17. {View of an unlabeled, open 5-gallon container in Building 61 containing an unknown liquid. A nearby 5-gallon bucket was labeled “Dirty PF.”}

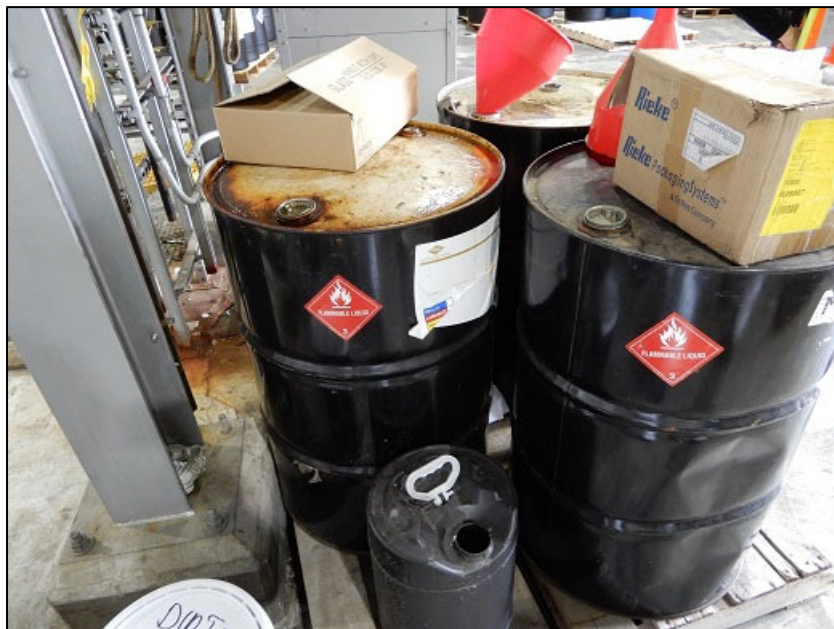
{Photograph 24}

18. {View of a 55-gallon drum (left) inside Building 61 containing a flammable liquid. Note that the drum was not labeled with the name of the chemical contained.}

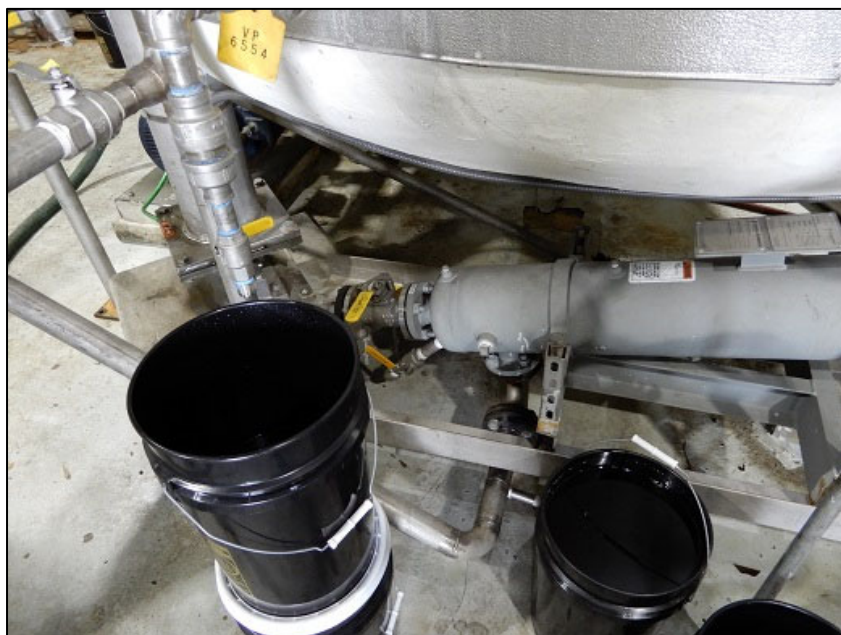
{Photograph 25}

19. {View of two open, unlabeled buckets containing an unknown liquid inside Building 61.}

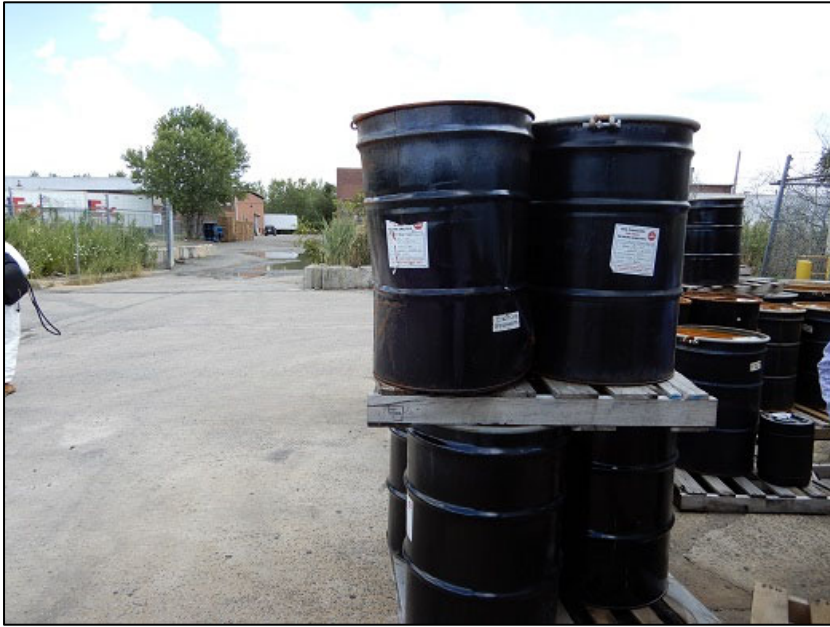
{Photograph 26}

The inspection team observed 55-gallon drums stored outside and uncovered in an area behind Building 61 that slopes toward a neighboring property. There were 52 drums labeled” Purge & Decontamination Water” from 12/2018, “Soil Cutting” from 2/2019, “On Hold Pending Analysis.” Mr. Zedeck stated that these drums contained drill cuttings, purge water, and other materials from remediation activities at the Superfund site at the Facility.

20. {View of 55-gallon drums stored outside and uncovered in an area behind Building 61 that slopes toward a neighboring property. There were 52 drums labeled “On Hold Pending Analysis.”}

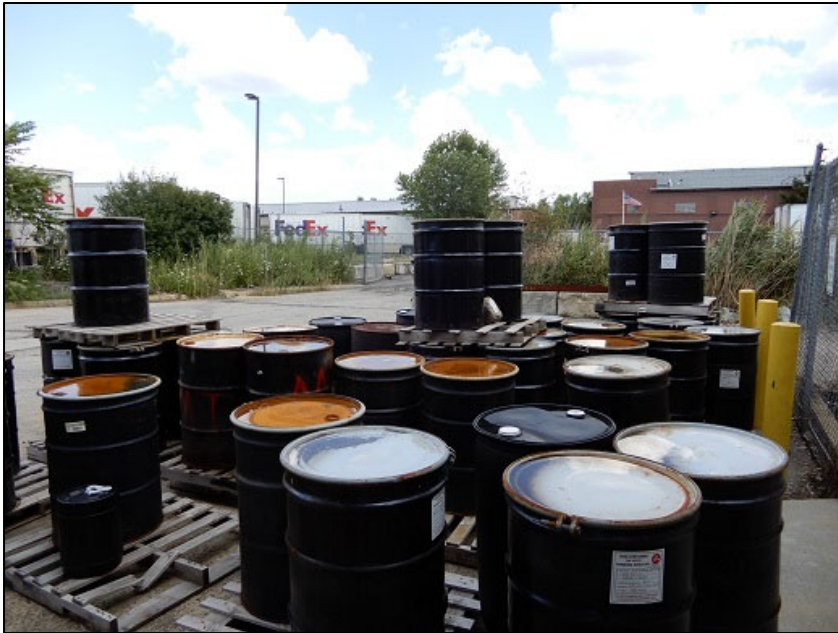
Photograph 27}

21. {Alternate view of 55-gallon drums stored outside and uncovered in an area behind Building 61 that slopes toward a neighboring property. There were 52 drums labeled “On Hold Pending Analysis.”}

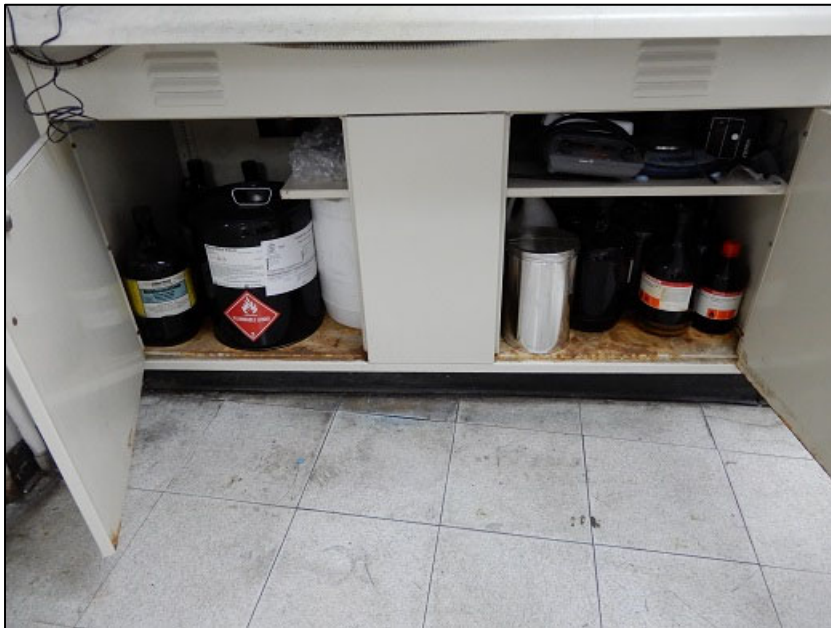
{Photograph 28}

- a) An inactive lab in the building with unused chemicals stored under the fume hood for two to three years.
- b) Two 55-gallon drums outside of Building 99 containing remediation wastes with labels stating, "Pending Analysis."
- c) Two additional unlabeled 55-gallon drums of remediation wastes along the east perimeter fence of the facility.

22. {View of various chemicals in a cabinet inside of the small lab area. Lab personnel stated that these chemicals had not been used in two to three years.}

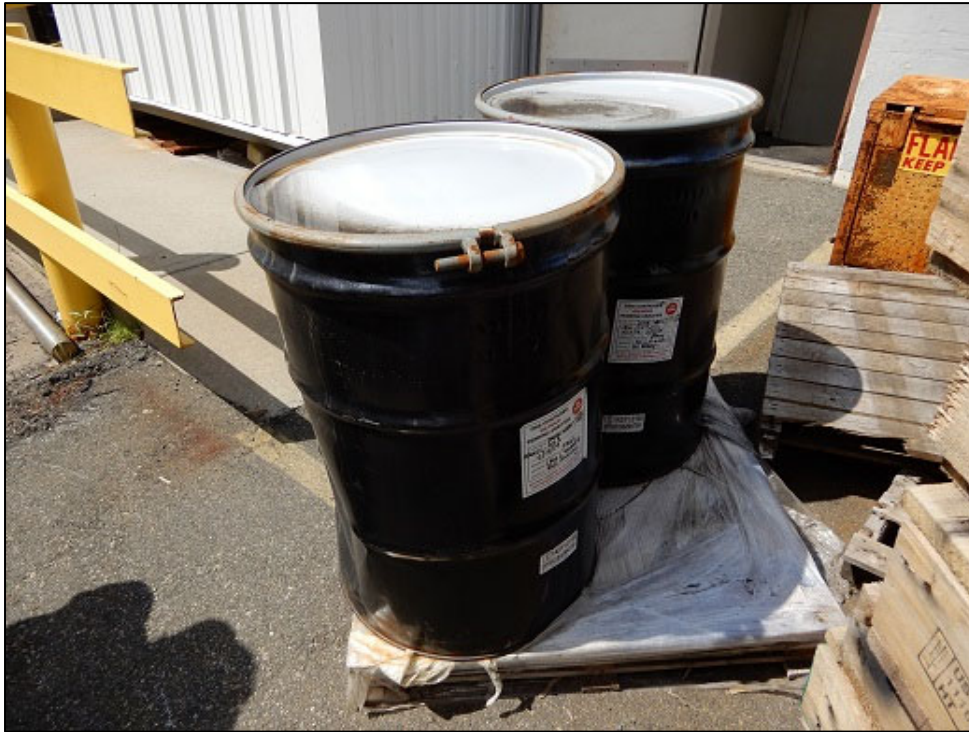
{Photograph 29}

23. {View of two 55-gallon drums outside of Building 99 with labels stating, “Pending Analysis.”}

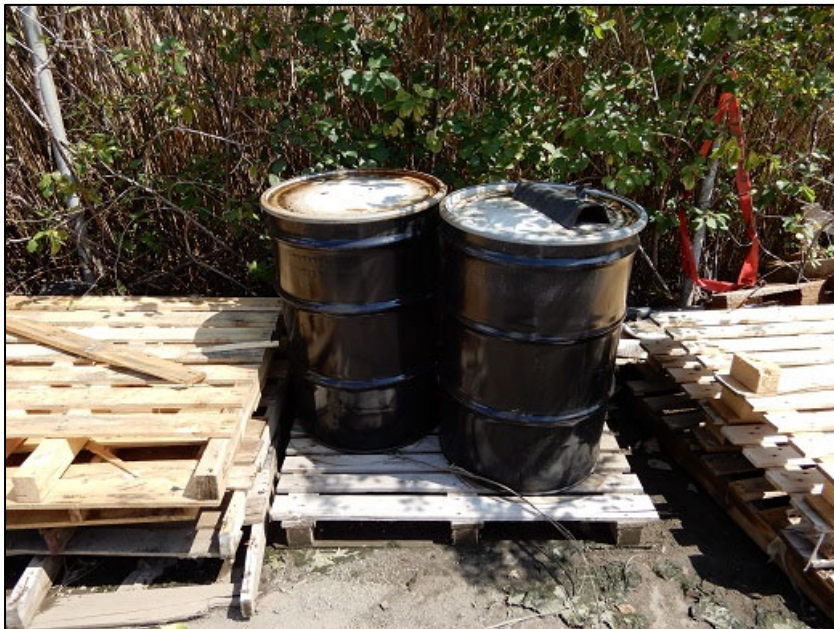
{Photograph 30}

24. {View of two unlabeled 55-gallon drums along the east perimeter fence of the facility.}

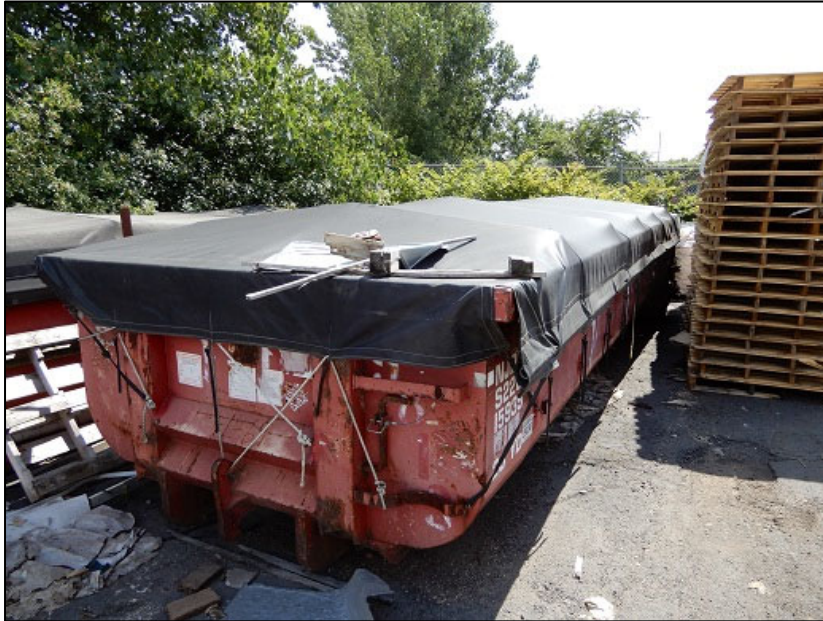
{Photograph 31}

Two roll-off containers were found storing contaminated soil adjacent to Building 65. This waste was generated from remediation conducted on site. Each roll-off container had hazardous waste labels on them but were weathered so the writing on the labels was unreadable. These are same roll-off containers that were identified in the 2014 inspection report and have been on site more than five years, exceeding the 90-day storage limit.

25. {View of the two roll-off containers containing contaminated soil from the Superfund site.}

- Two roll-off containers were found storing contaminated soil adjacent to Building 65. This waste was generated from remediation conducted on site and placed in the roll-off containers in 2014. The labeling on the roll-off containers was faded and unreadable.

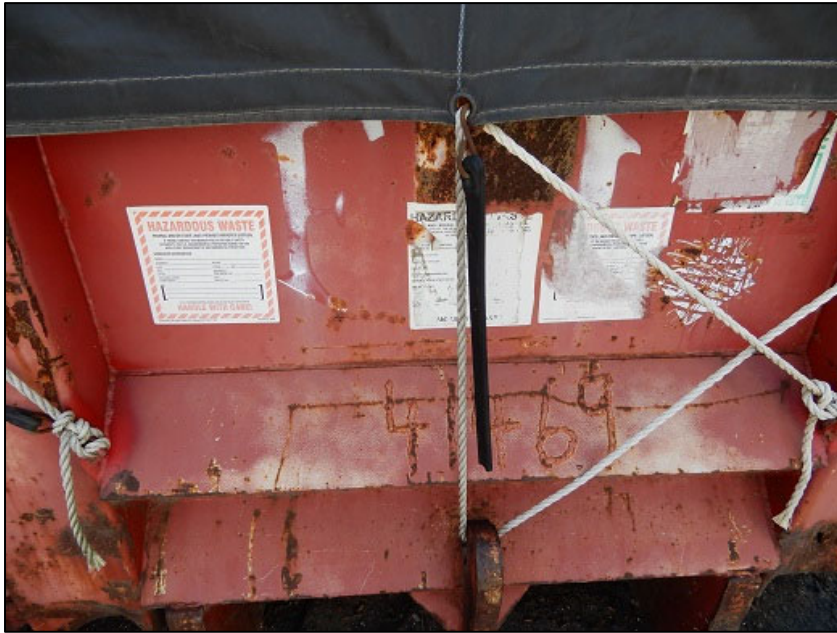
{Photograph 32}

26. {Close-up view of the hazardous waste label on the right roll-off container in Photograph 33. The information on the label was faded and unreadable.}

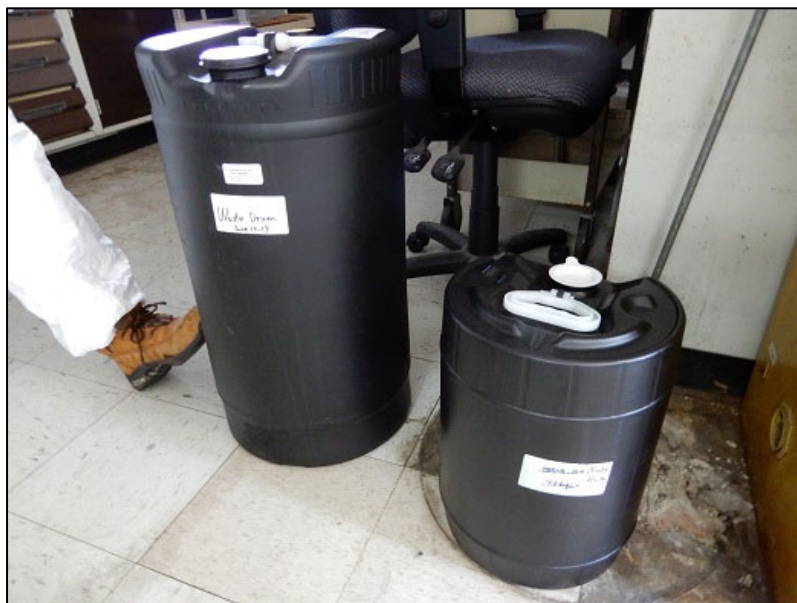
{Photograph 34}

The inspection team conducted a walkthrough of the former R&D Lab/Building 99. The R&D Lab was moved to another facility. The inspection team observed two containers of waste from the cleanup of the R&D Lab. The two containers were labeled “Waste Drum”. The containers were dated 6/12/2019 and no information on the contents or the hazards of the wastes in the containers was available.

27. {View of two containers labeled “Waste Drum” inside the old R&D Lab/Building 99. The containers were dated 6/12/2019 and no information on the contents or the hazards of the wastes in the containers was available.}

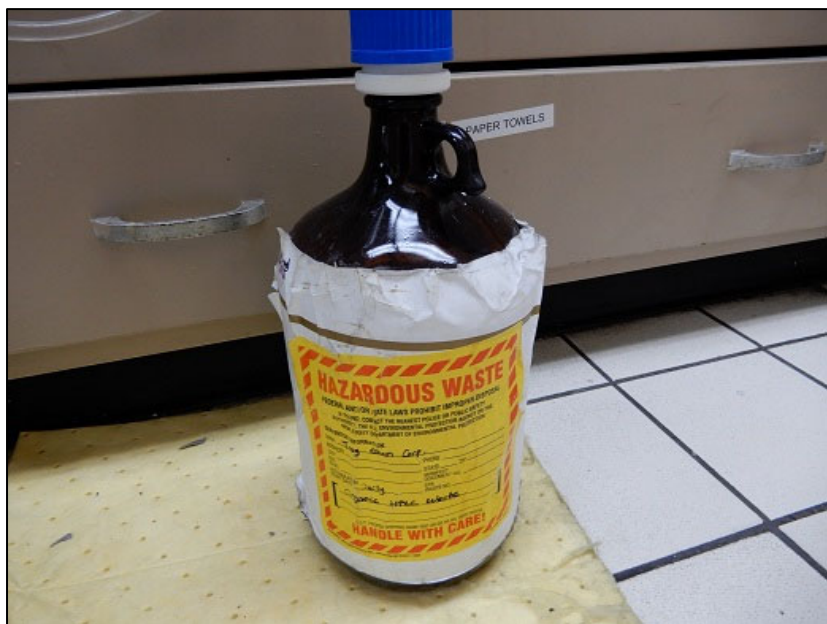
{Photograph 35}

The inspection team conducted a walkthrough of the QA Lab. Hazardous waste was found in the QA lab where raw materials and finished products are analyzed. HPLC machines located in the lab generate acetonitrile/methanol waste that drains directly into 4-liter satellite accumulation containers (SAC). In addition, there was one 4-liter SAC of waste toluene and another 4-liter SAC of waste toluene and methanol in a fume hood.

28. {View of a small hazardous waste container inside the QA lab. The label only states “Organic HPLC Waste” and does not list the specific hazards.}

During the inspection, I observed that none of the SAAs in the Building 1 QA lab had the hazards identified on the SAA hazardous waste containers.

After the inspection, Troy added the hazard to the hazardous waste containers in the SAAs (See Photograph 8 Attachment 14). The hazardous waste labels on the 55-gallon drums in the SAA in the warehouse did not contain any information about the contents of the drum.

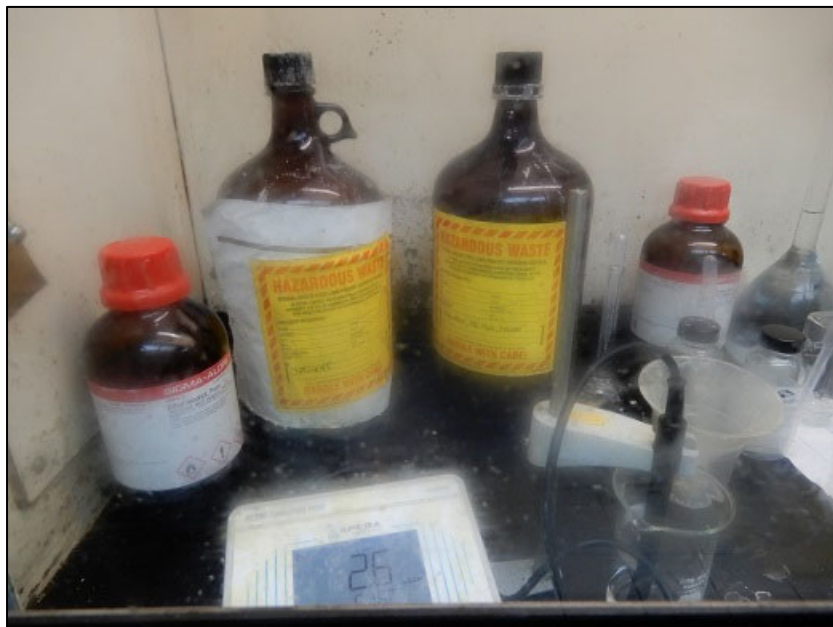
{Photograph 36}

29. {View of additional small hazardous waste containers inside the QA lab. The labels do not list the specific hazards.}

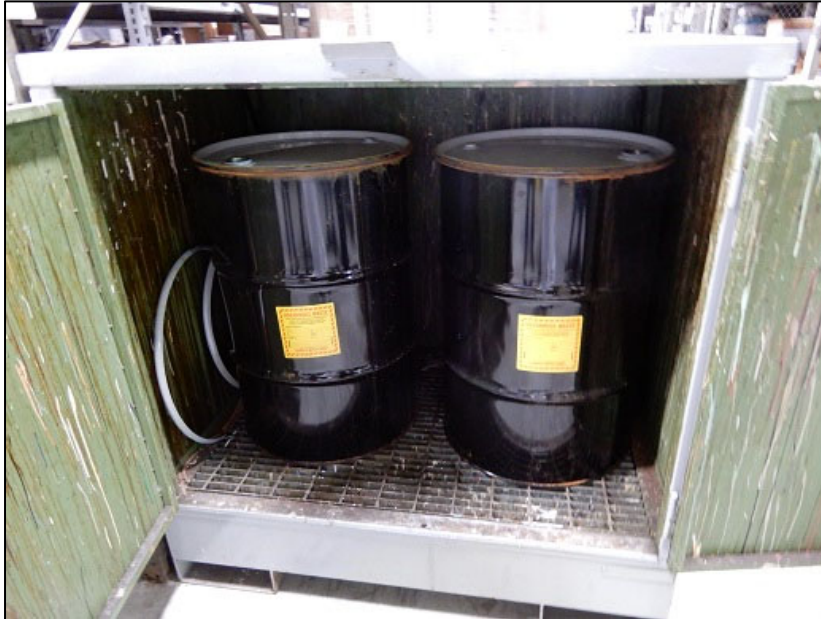
{Photograph 37}

The inspection team observed a satellite accumulation area for lab waste located in the warehouse adjacent to the QA lab. There were two 55-gallon drums labeled as containing hazardous waste, but the contents of the drums and the hazards of the wastes were not identified on the label. One of the drums was full but was not dated.

30. {View of the satellite accumulation area for lab waste located in the warehouse adjacent to the QA lab. Note that there were two 55-gallon drums labeled as containing hazardous waste, but the contents of the drums and the hazards of the wastes were not identified on the label. Lab personnel stated the drums contain the same type of lab hazardous waste.}

During the inspection, I observed two 55-gallon drums of hazardous waste stored in a SAA for the Building 1 QA lab in the warehouse. The SAA in the warehouse is not under the control of the QA lab. One of the drums was full and did not have the date the excess amount began accumulating on the full drum.

After the inspection, Troy designated the second drum as non-hazardous materials only (See Photograph 3 Attachment 14)

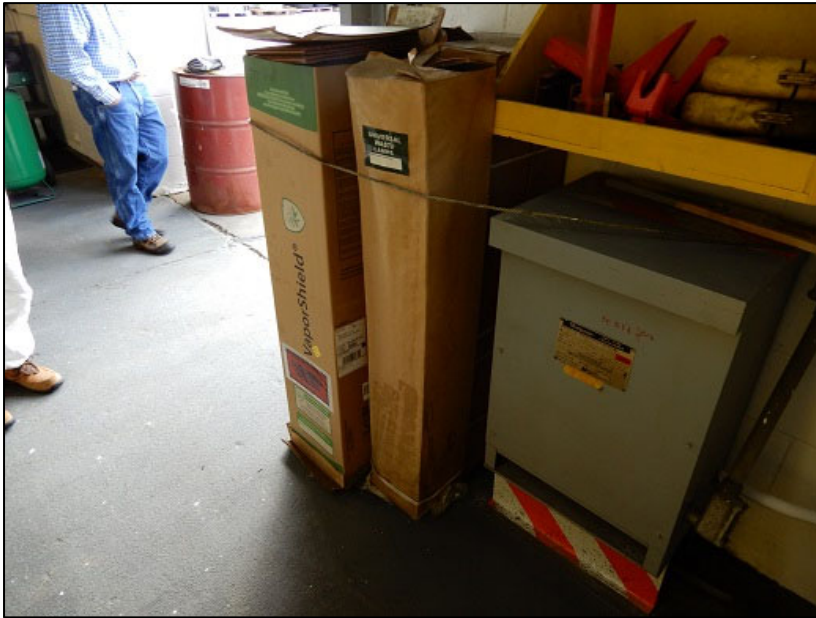
{Photograph 38}

The inspection team conducted a walkthrough of the Maintenance Building. The inspectors observed a box of used fluorescent lamps that was not dated. The inspectors also found a metal-halide lamp in the trash and removed the lamp to put in the used lamp box.

31. {View of the universal waste storage area inside the Maintenance Building. Note that the lamps were not dated.}

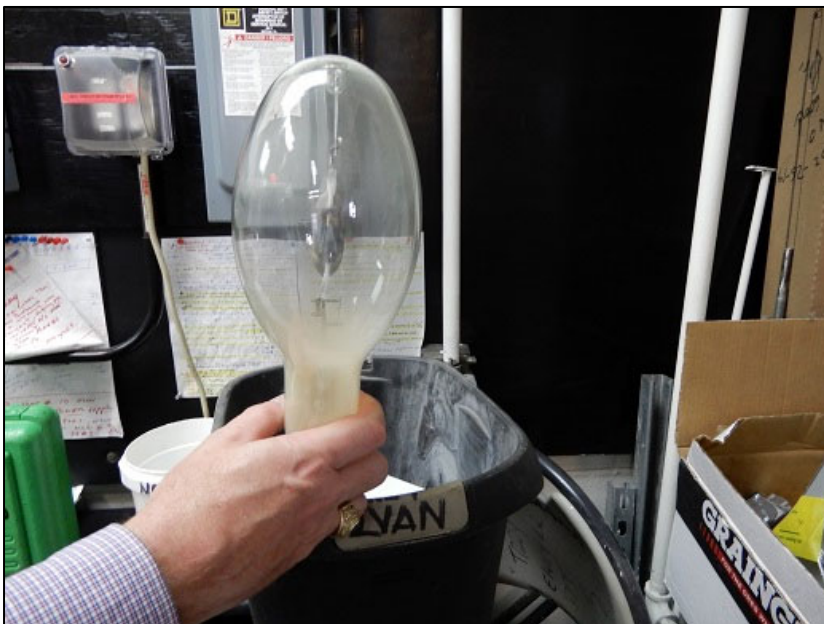
{Photograph 39}

32. {View of a used lamp inside the Maintenance Building that was found in a garbage container separate from the universal waste storage area.}

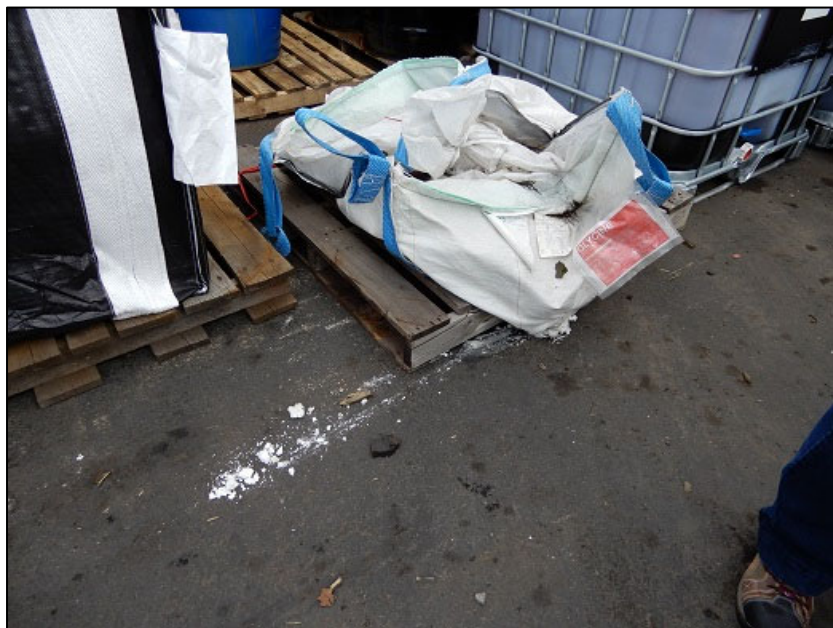
{Photograph 40}

- a) A super sack of raw material labeled “Glycine – store in a cool dry place” was open and spilled on the ground near the south side of Building 71.
- b) A pallet of 5-gallon buckets stacked three high near the south side of Building 71 appearing to be waste and had various labels including “Unknown Pending Analysis” and “Selenium Dioxide.” The pallets were falling apart, and the stack of buckets was not very stable.
- c) A drum near the south side of Building 71 was labeled “Waste Chemicals” and dated “1/10.” It was not clear what chemicals were in the drum or the hazards associated with the chemicals.

33. {View of a bag labeled “Glycine – store in a cool dry place” open and spilled on the ground near the south side of Building 71.}

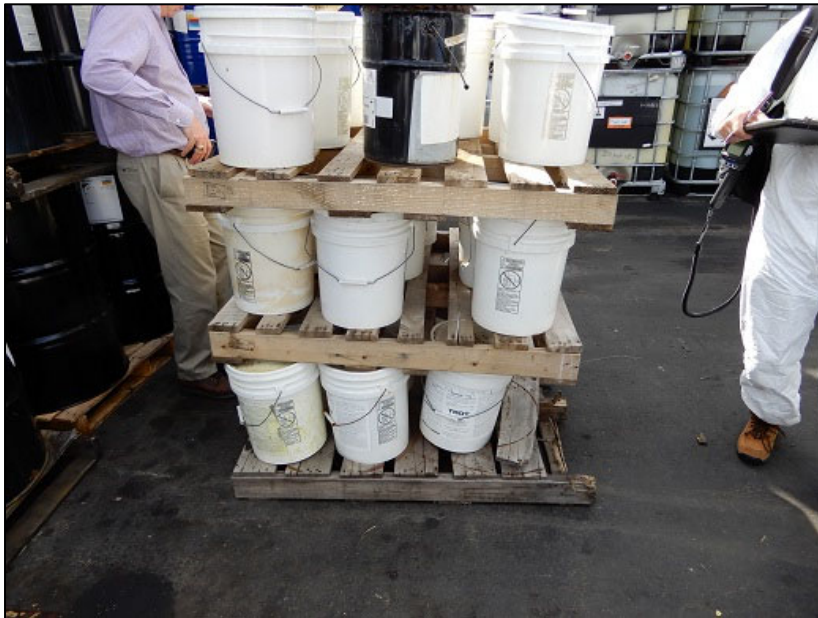
{Photograph 41}

34. {View of a pallet of 5-gallon buckets near the south side of Building 71. The buckets contained various labels including “Unknown Pending Analysis” and “Selenium Dioxide.” Note that the pallet did not appear stable.}

- A pallet of 5-gallon buckets stacked three layers high near the south side of Building 71 contained various labels including “Unknown Pending Analysis” and “Selenium Dioxide”.
- Two containers labeled “Waste Drum” inside the old R&D Lab/Building 99 were dated 6/12/2019 and no information on the contents or the hazards of the wastes in the containers was available.
- Two 55-gallon drums outside of Building 99 containing remediation wastes with labels stating, “Pending Analysis.”
- Two additional unlabeled 55-gallon drums of remediation wastes along the east perimeter fence of the facility.

After the inspection, Troy labeled the selenium dioxide wastes as hazardous waste and moved them to the 90-day storage area (See Photograph 6 Attachment 14)
